County Bridge T-19-S

Public Information
Meeting

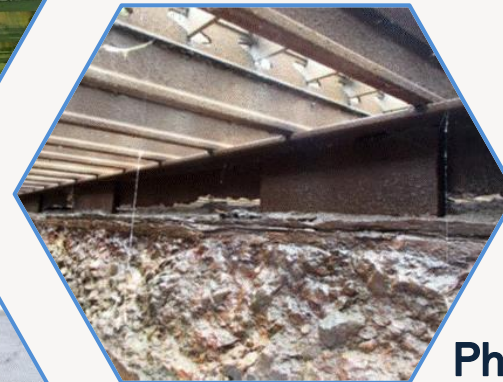
[See Photo(s): 7, 9, 11]

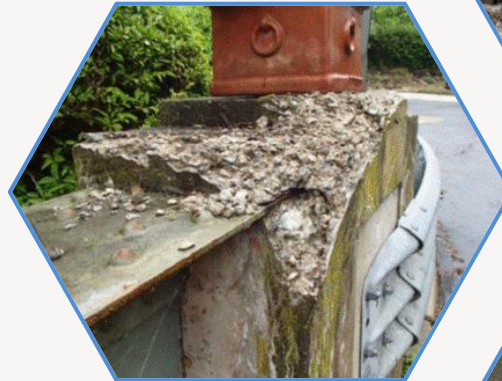
[See Photo(s): 13, 14].

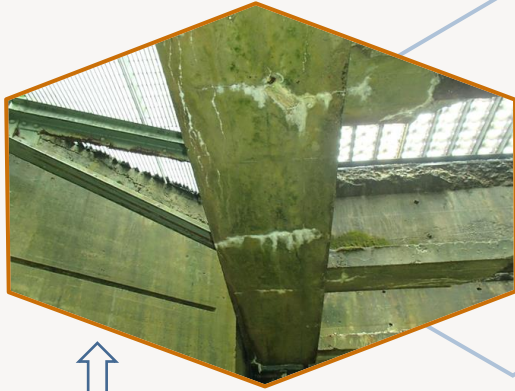
Photo 23
Remaining encasement exhibits fine transverse cracks (spaced 2' to 3') and scattered fine longitudinal cracks, all with light efflorescence stains

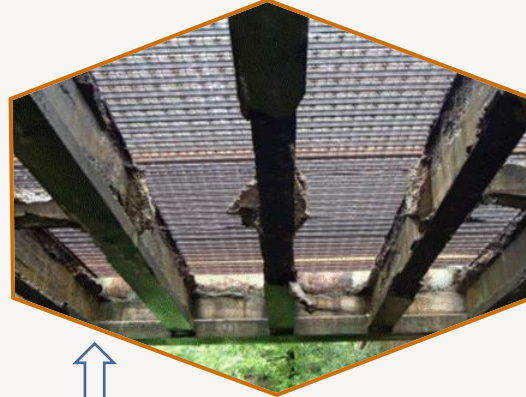
Photo 26
Bays 13W & 14W (4): Concrete completely spalled away/missing with exposed and severely rusted tie rods (est. 70% loss)

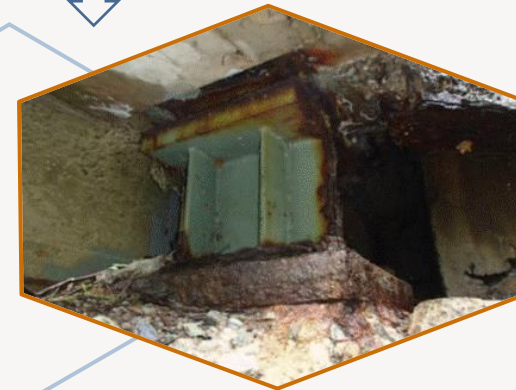
Photo 27
Heavy scaling / disintegration of bridge seat up to bearing masonry plate with minor undermining of southwest corner (< 5%)

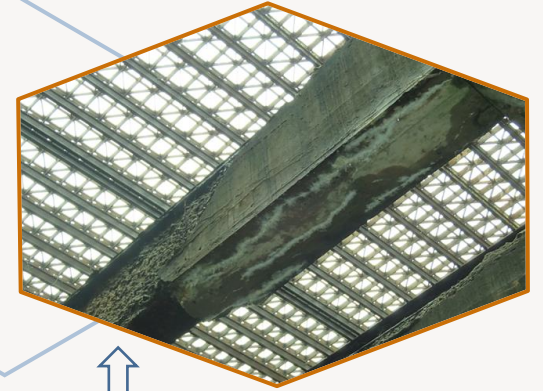
Photo 29
FB13W thru FB18W: Spalled / missing bottom flange encasement (~ 50% missing). Cracks with efflorescence on the underside of bottom flanges where encasement remains [See Photo(s): 29].

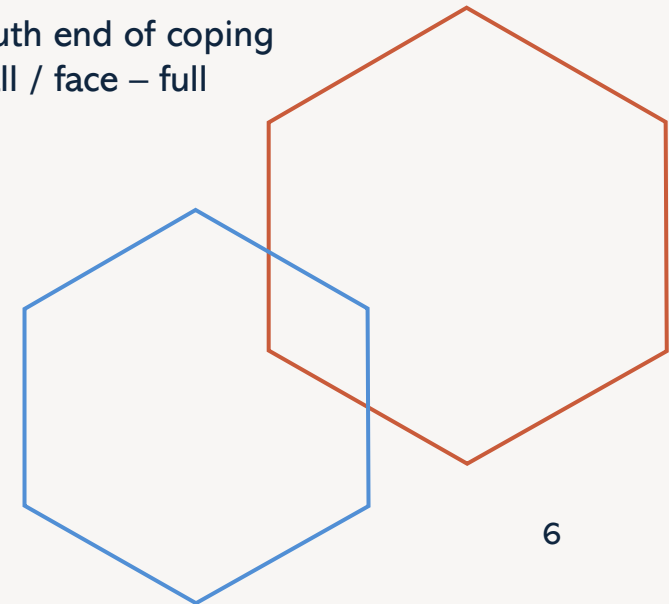
Historical Data of Work Completed (Last 5 Years (2017-2022))

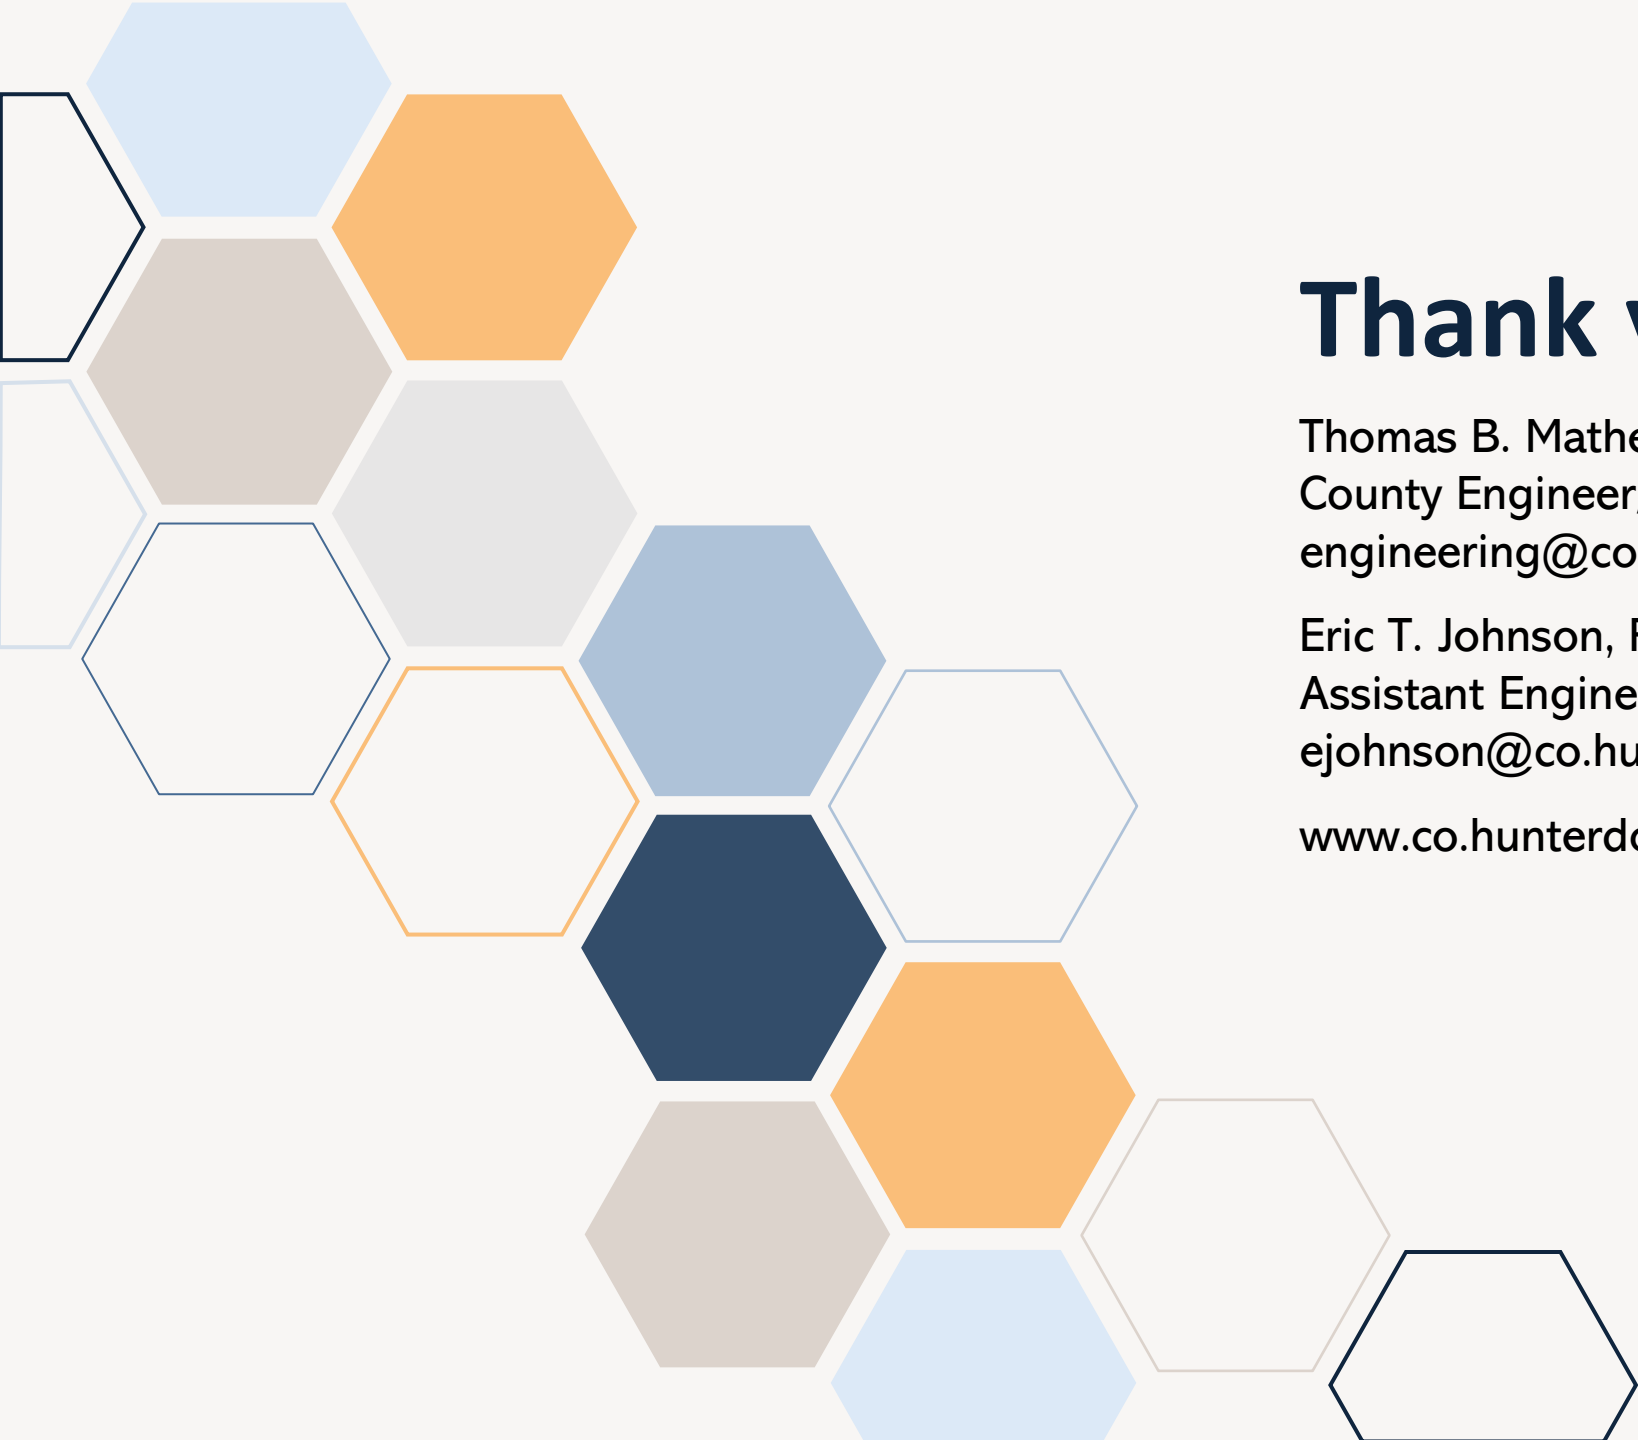
Source: N.J.D.O.T. Structural Evaluation and Bridge Management Bridge Re-Evaluation Survey Report; Cycle 20 Dated 6/3/2021
