County Bridge T-19-S

Public Information
Meeting

Source: N.J.D.O.T. Structural Evaluation and Bridge Management Bridge Re-Evaluation Survey Report; Cycle 20 Dated 6/3/2021

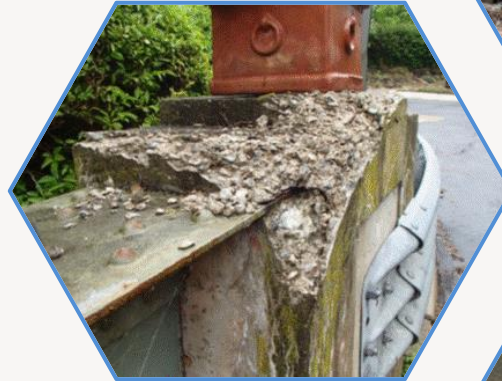
Photo 13

Heavy scaling with disintegrated concrete at top southwest corner, with adjacent cracks and unsound concrete (8 SF total) Wide fracture (3"W) at base* where backwall meets sidewalk

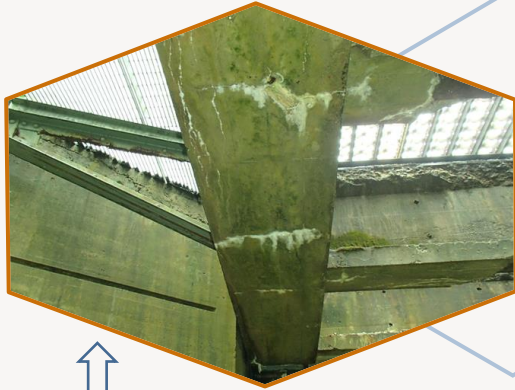
Photo 23
Remaining encasement exhibits fine transverse cracks (spaced 2' to 3') and scattered fine longitudinal cracks, all with light efflorescence stains

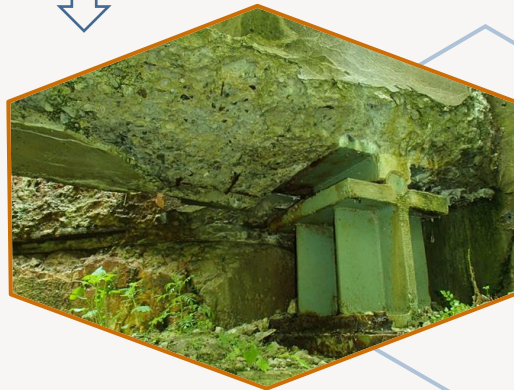
Photo 24
Spalled bottom flange encasement at west end of girder (10 LF) with adjacent unsound concrete

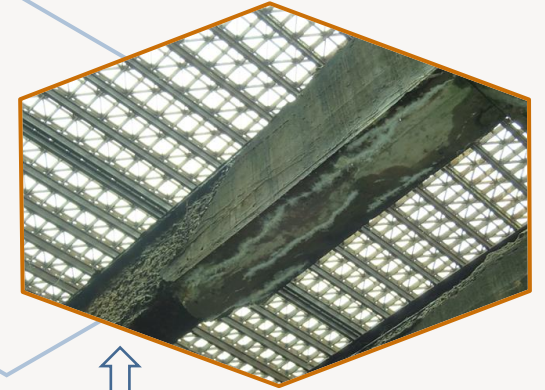
Photo 29
FB13W thru FB18W: Spalled / missing bottom flange encasement (~ 50% missing). Cracks with efflorescence on the underside of bottom flanges where encasement remains [See Photo(s): 29].

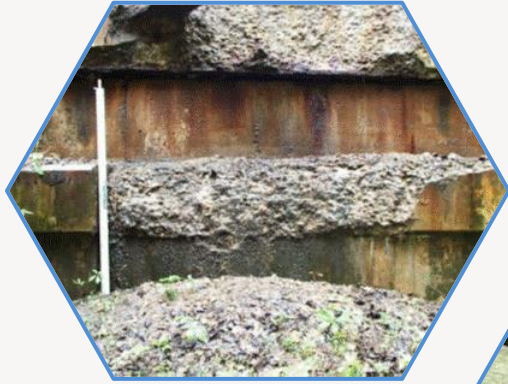
Photo 32

Coping: Severe scaling/disintegration up to 18" high x 6" to 10" deep at north 1/3 point (6 LF) and at center (7 LF), with concrete easily removed in scaling [Photo: 32].

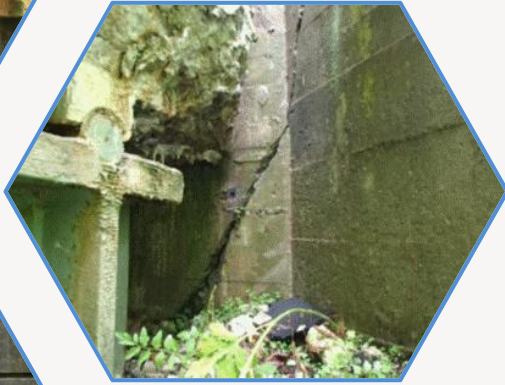
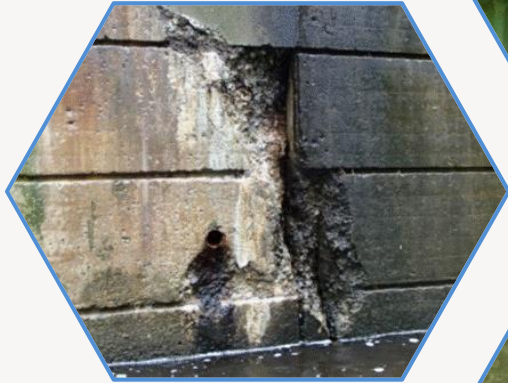
Photo 33

Wide diagonal fracture, full height (2 LF) at both ends (behind girders) extending into wingwall/cheekwall [Photo: 33].

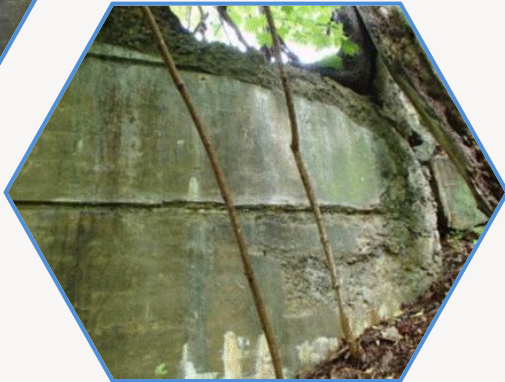
Photo 34

Large spall at construction joint 10' +/- from north end (6' high x 2' wide) up to 12" deep with exposed and rusted rebar, concrete in spall generally intact [Photo: 34].
